Best Practices for Road Weather Management

Montana DOT Anti-Icing/Deicing Operations

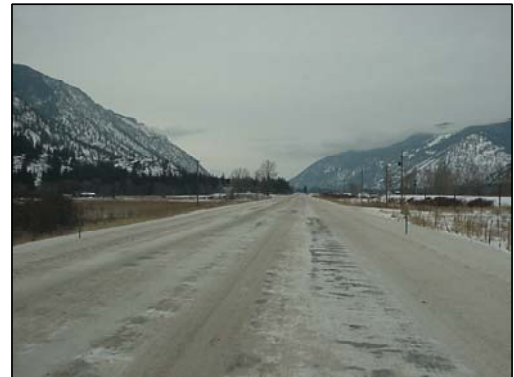
Thompson Falls Section

Once the storm passed, numerous complaints were received from drivers due to striking differences in road surface conditions in the area separating the Plains and Thompson Falls road sections. The pavement was bare in Plains section, while the Thompson Falls section was compacted with snow and ice.
